14 PTPD REPORT NO. 76-34  
16 AFPEA-REPORT NO. 76-P7-40

CNU-179 A/E CONTAINER  
ROUGH HANDLING AND VIBRATION TEST.

HQ AFALD/PTP  
AIR FORCE PACKAGING EVALUATION AGENCY  
Wright-Patterson AFB OH 45433

October 1976

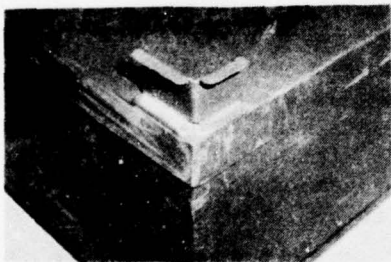
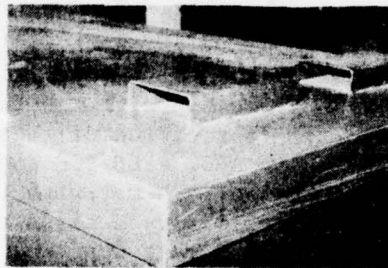
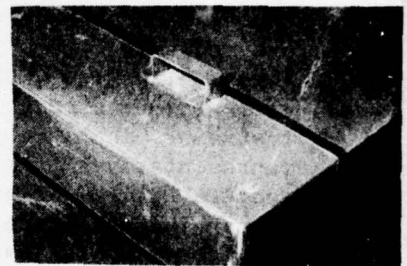
Figure 2. Stacking Lug Options

The second set of impacts was made on container II-1 with III-1 container stacked on top. The corners of the lid on the bottom container (II-1) split and allowed the lid to slide forward. The rotation of the top container around the forward lug was greater than in the impact above but not great enough for the top container to slide off. All four lugs on the bottom container were bent in the direction of impact.

4. Test B3-5 and 6. This test indicated the structural integrity of all lug designs. Also, the increase in impact force did not appreciably damage the container. (Since these containers will probably be shipped in a stacked configuration, this test was a good indication of what could be expected as far as load stability.)

3. The design of the stacking lugs is part of this evaluation. From all indications in the two-high pendulum impact test, the lug style I, Figure 2, page 2, appears the optimum to use. The other two styles proved difficult to stack from the standpoint of forklift operations.

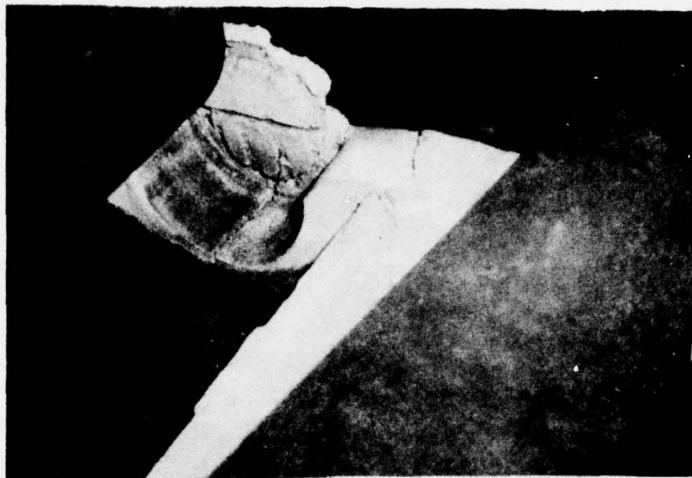
The initial edgewise drop (B2-1) separated a bottom corner weld, continued the buckling started in the cornerwise drop and started a crack in two places on the longitudinal skid and one on an end traverse skid. The center vertical strap broke causing the center to bend. The second edgewise drop (B2-2) did not seem to appreciably increase damage to the container, other than continuing damage already present. The container was still usable after these tests. The CBU-58B dispensers were inspected at this time and were found to be in good condition. The polystyrene blocking and bracing had minor dents and cracks but was still serviceable (as shown in Figure 8, page 15). Again, no reading was obtainable from the oscilloscope recording system. Four vertical straps were used to reseal the container.

Figure 9. Aft End Damage

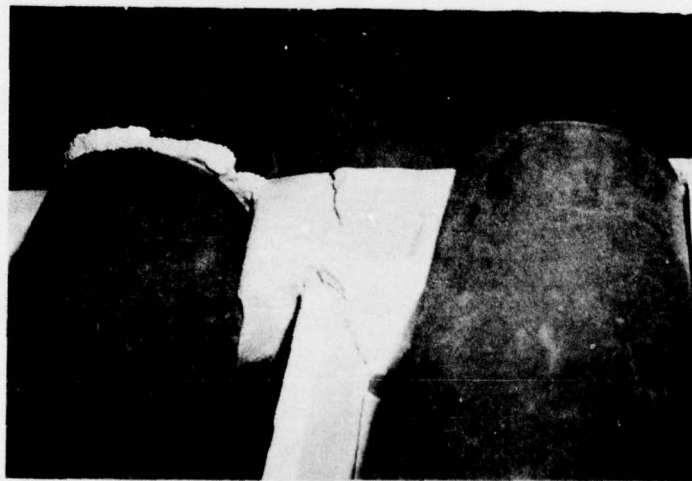
This test resulted in additional internal and external damage to the container. The damage is shown in Figures 10-13, pages 16 thru 18. The bottom of the external container was further distorted and three cracks developed at various stress points on the container. The interior blocking and bracing was chipped in many places with cracks developing at the ends. One end was broken out but was still providing protection. There was no damage inside or outside that disqualified this container, however, as in the first vibration test, one dispenser rotated. The degree of rotation was approximately 25°.

Figure 10. Divider Damage

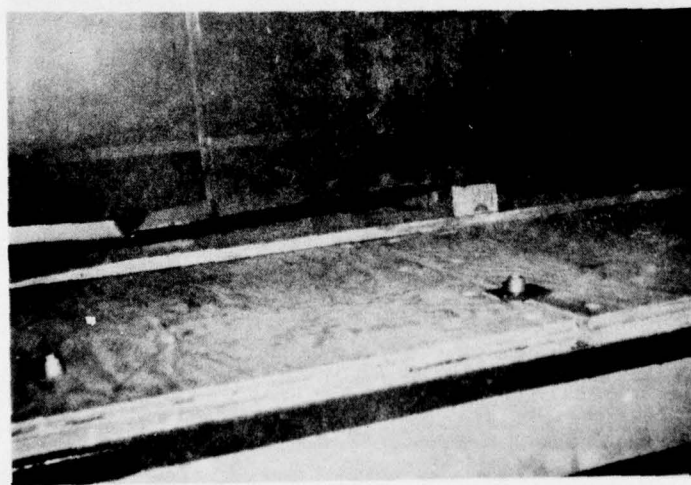
3. Test A1-2. The cracks that developed at the stress points could be an indication that the bottom panel should be strengthened either by the addition of stiffeners or increasing the gauge of the panel.

Figure 12. Container Side Damage

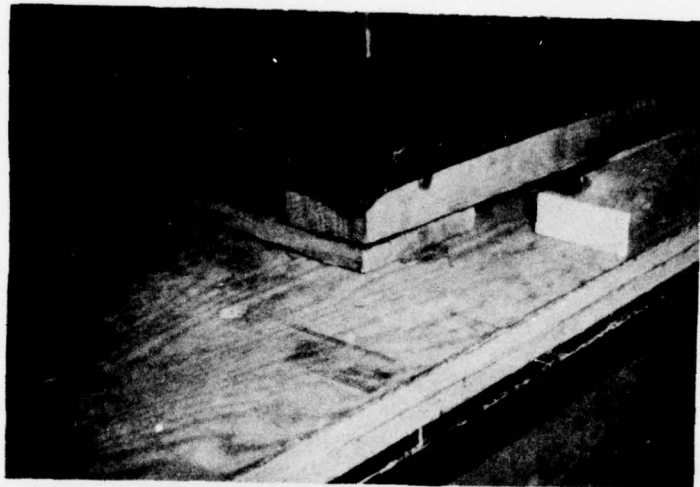
Figure 13. Container End Damage

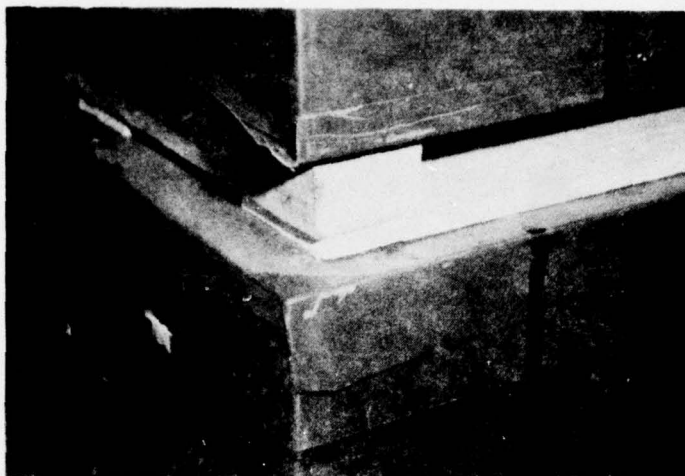
The first set of impacts was made on container III-1 with II-1 container stacked on top. There was no appreciable damage connected with this impact as shown in Figure 15, page 19. There was a slight rotation of the top container around the forward lug.

Figure 15. Pendulum Corner Damage
